Aging Weapons Systems Repair using Friction Stir Welding

Bryan M. Tweedy¹, William A. Arbegast², Robert H. Hrabec¹ and James M. Hutto¹

¹ H.F. Webster Engineering and Professional Services, Rapid City, SD 57702 USA

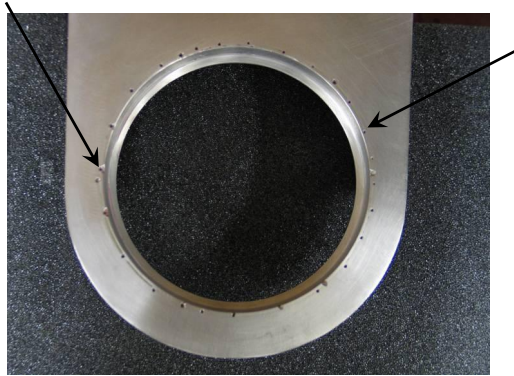
The purpose of this FY07 Aging Aircraft Study [1] was to investigate the use of advanced processing technologies such as friction stir welding and processing, laser deposition and cold spray in repair/remanufacturing applications of aging weapons systems. In particular, friction stir welding and processing presented some unique opportunities to repair worn or cracked components. One of the chosen parts for this remanufacturing study is the ruddervator fitting for the KC-135 re-fueling boom (Figure 1). This structural component is responsible for connecting the re-fueling boom to the rudder shaft. The component has two ears, each with a bearing race. When the bearings are installed, it is common to use a punch and hammer to deform the part and stake the bearing in place. Unfortunately, these stake marks are stress concentration points and form fatigue cracking when placed into service. A picture of the typical stake marks in the ruddervator fitting is shown in Figure 2.

Figure 2: Typical Stake Damage to a Ruddervator Ear

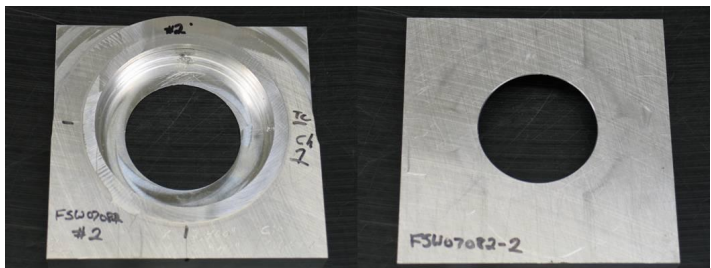
Parts were re-machined to remove the plugs from the bearing bores and radiographically inspected at Ellsworth AFB, Rapid City, SD (Figures 11-12).

Figure 11: Surrogate 2 Post-machining

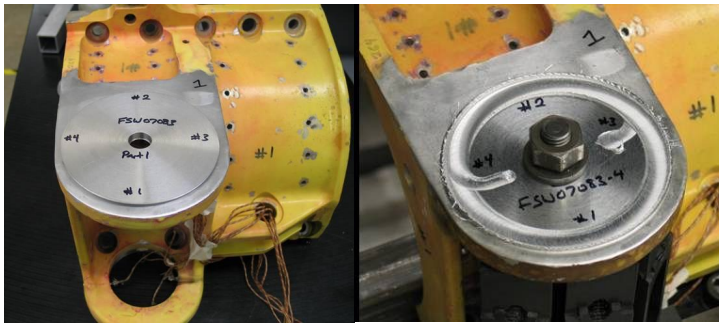
The prototype ruddervator fitting was cleaned with a solvent wipe and the machined plugs were pressed into place (Figure 14). Standard tooling was used and was similar to the setup used in welding the surrogate parts in the previous section. This was important to avoid differences in the thermal and mechanical conditions used in the development of the repair process to aide portability between surrogate and prototype production. Welds were made using the parameters developed in the previous section (800 rpm, 8 ipm) while thermal data was being collected via a data acquisition system. Welds were made counter-clockwise about the center of the plug, with two inner passes followed by two outer passes. Following welding, the resultant plugs were machined from the ruddervator fittings and the repaired part was radiographically inspected which revealed that no volumetric defects remained in the part.

Figure 14: Dry-fit of Repair Plug (left) and Post Weld Repair (right)
